**CASE STUDY: HOW THE FIRST OCCUPANT BEHAVIOR DEHUMIDIFICATION SOLUTION
 FOR APARTMENT LIVING WAS CREATED**

Innovative Dehumidifier Systems, LLC
Ocean Isle Beach, North Carolina

APARTMENT DWELLING, MULTI-FAMILY HOUSING: SOUTHERN PINES, NORTH CAROLINA

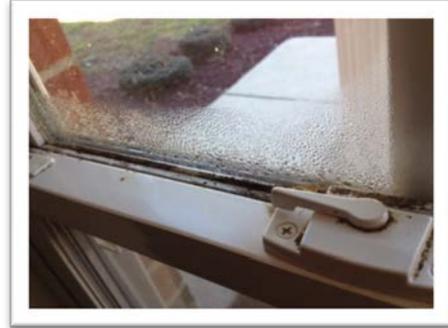
The entire multi-family building consisted of 16 units, 8 on the ground floor and 8 on the second floor. Four units on the ground exhibited various moisture and indoor humidity issues, ranging from minor to major. These issues included window condensation, wet sheetrock surfaces, wet carpet/flooring, and the presence of mold. This case study broadly analyzes the entire range of issues, while specifically focusing on the one unit with the most inherent moisture and humidity problems (Unit #101). Because of the high humidity and excessive moisture, Unit #101 was plagued by sweating windows, musty odors, and poor air quality with the elevated humidity levels.

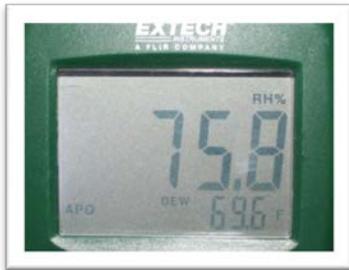
Unit #101 was a ground floor unit that was north facing and located very near a wooded area, which prevented the unit from being exposed to direct sunlight for more than just 4 to 5 hours a day. At the time of our inspection of this multi-family complex, Unit #101 had the highest Relative Humidity (RH) readings, ranging from 75.8% to in excess of 90%. For visible mold growth to occur an elevated relative humidity, typically higher than 60%, needs to be present.

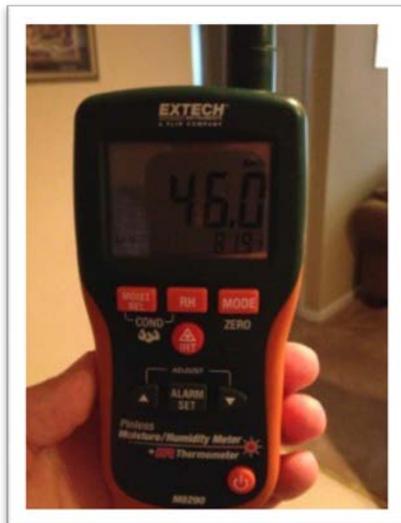
Relative Humidity Conditions after installation

Kitchen 46.0% RH

After the prototype was installed relative humidity and moisture readings were taken inside the apartment on a weekly basis or bi-weekly basis. Relative humidity readings in every visit ranged from 41 – 50% RH, well below the 60% RH noted as the environment which encourages visible mold growth.

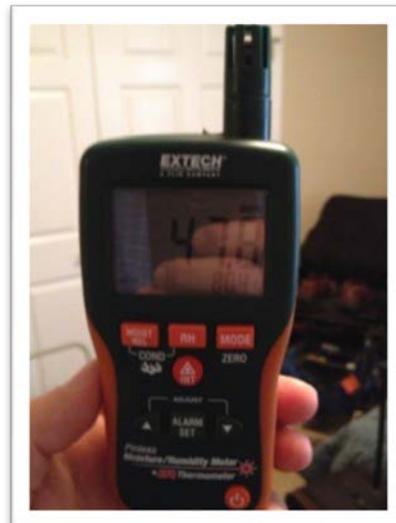
Rear Bedroom 47.8% RH
