4BR Student housing, garden-style apartments

Southern Coastal Texas

IN-WALL DEHUMIDIFIER SYSTEM SAVES UP TO \$250,000 IN REPLACEMENT WINDOW COSTS

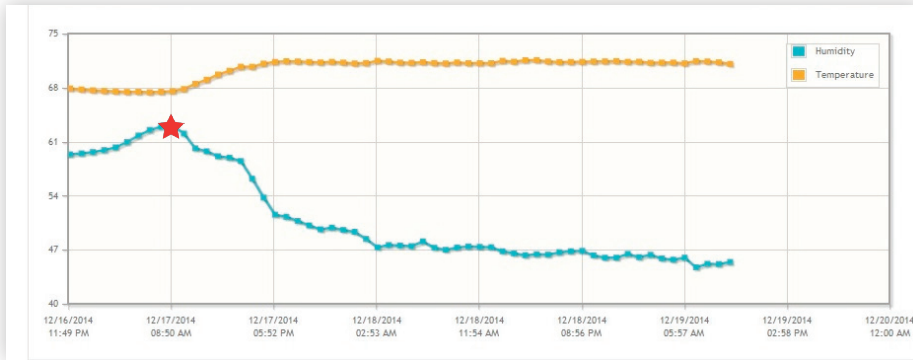
MONITORING UNIT 419

- Began Tuesday afternoon, December 16, 2014, using an iMonnit data logger.
- RH inside the apartment prior to installation remained at or above 60%.
- IW-25 was installed on Wednesday, December 17 at 8:50am.
- At 3:30pm on Wednesday, December 17, the IW-25 humidistat was set to 45% RH.
- Less than 12 hours later, RH in the unit had been reduced to 47%.
- Several hours later, RH in the unit was further reduced to 45%.

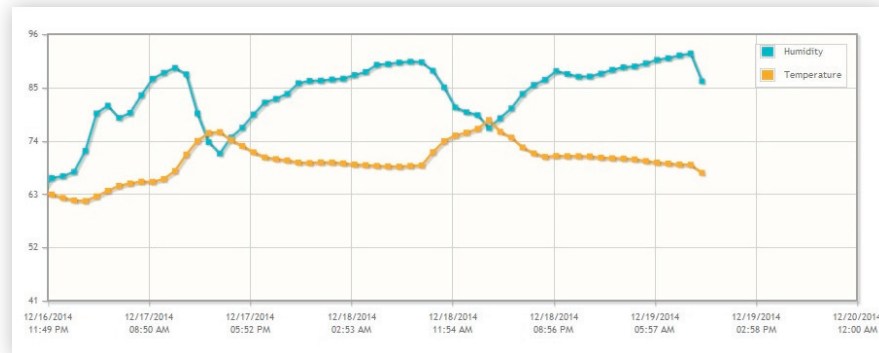
OUTDOOR MONITORING

Ambient humidity remained high at, or in excess of, 90% for a large duration of the sample period.
